# Manhole Inspection Summary

Manhole # S35A\_\_031MH

Insp Date: **8/21/08 8:40 AM**

**Location** Address: **500 n calvert st**

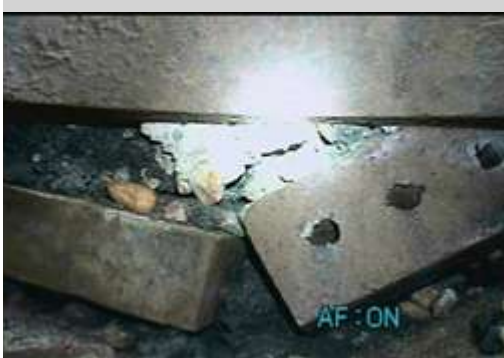
Defect 2

Condition: ☐ Sound ☒ **Cracked** ☐ Root Intrusion ☒ **Loose Brick** ☒ **Deteriorated**

cracked, loose brick and deteriorated chimney, frame adj

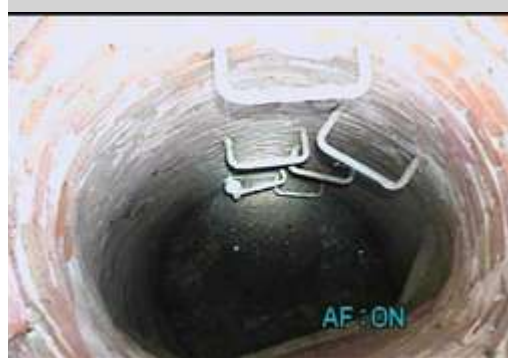
Defect 1

**Steps** Count: **6** Missing: **0** ☒ **Corroded**

corroded steps

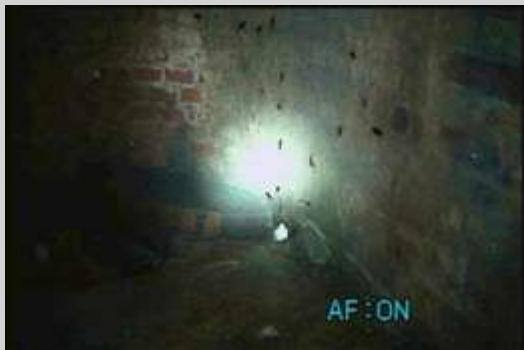
12 O'Clock Outflow

pipe way under shelf
